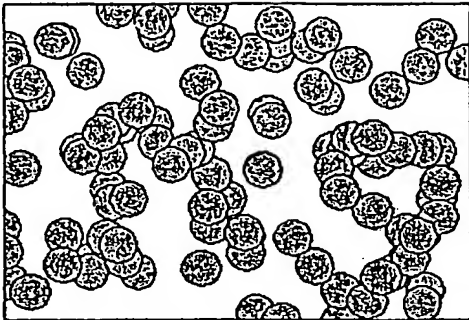
Fig. 7

Processing time : 2sec
Dent rate : 54.8%

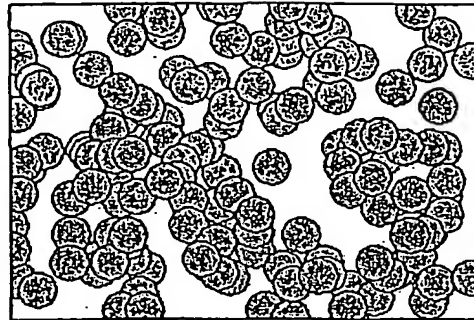
Processing time : 3sec
Dent rate : 69.6%

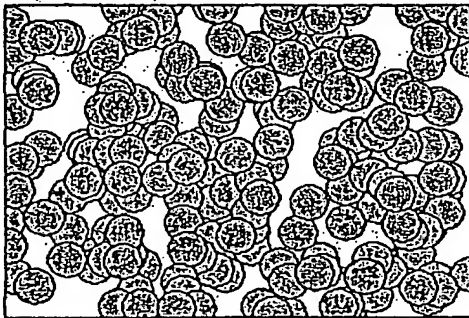
Processing time : 4sec
Dent rate : 79.6%

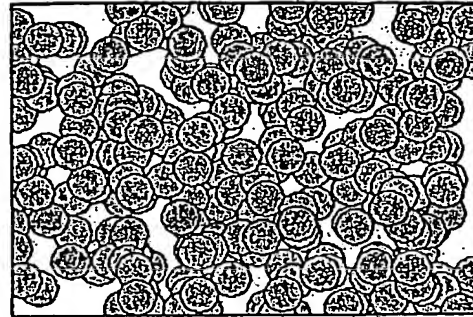
Processing time : 5sec
Dent rate : 86.3%

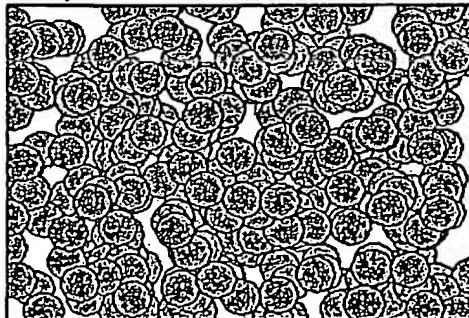
Processing time : 6sec
Dent rate : 90.8%

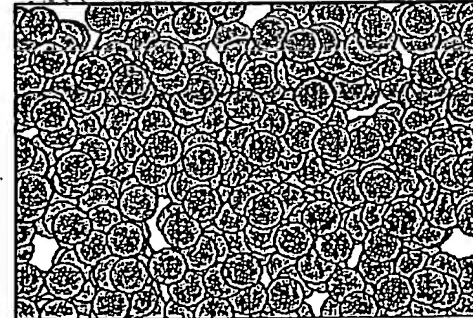
Processing time : 9sec
Dent rate : 97.2%
